# **REMEDIAL ACTION CONSTRUCTION AND COMPLETION REPORT**

## **LANDFARM REMEDY**

**Prewitt Refinery Site  
Prewitt, NM**

**February 1997**

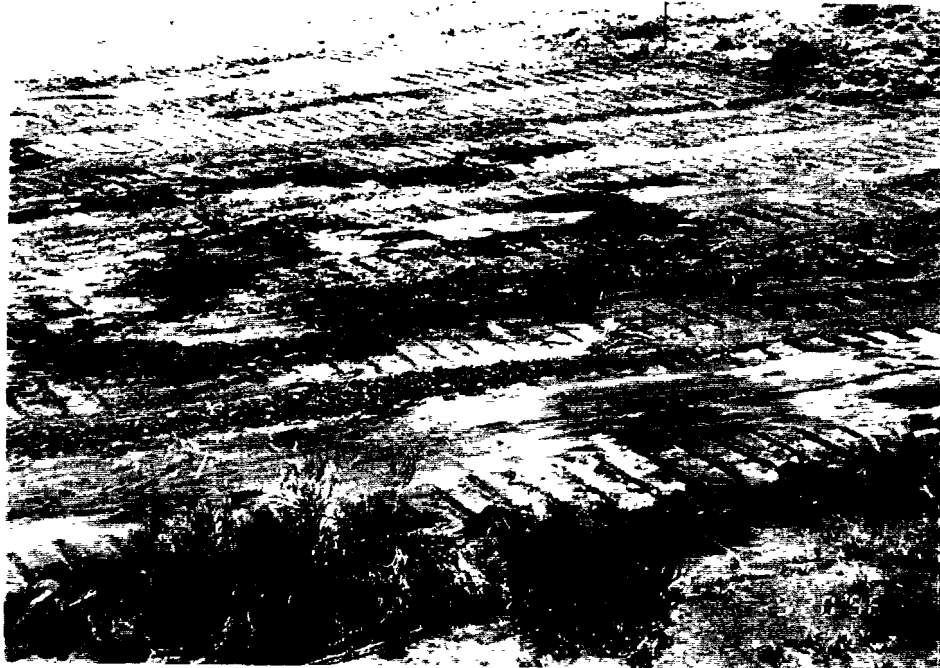
The soil mound and hydrocarbon stained soils, encountered during excavation for subgrade preparation (Photo 3-1), were also segregated and temporarily stockpiled near the West Pits for placement in the landfarm for treatment as shown in Photo 3-2. This soil volume was approximately 125 cubic yards. Confirmatory sampling of the excavation following removal of the hydrocarbon-contaminated soil from the landfarm was not performed for the following reasons:

Photo 3-1. Hydrocarbon-Stained Soils Encountered During Landfarm Subgrade Construction

- there was no visual indication of hydrocarbon remaining in the subgrade of the landfarm, and
- the location where the hydrocarbon-stained soil was removed will be 4 feet below grade following closure of the landfarm.

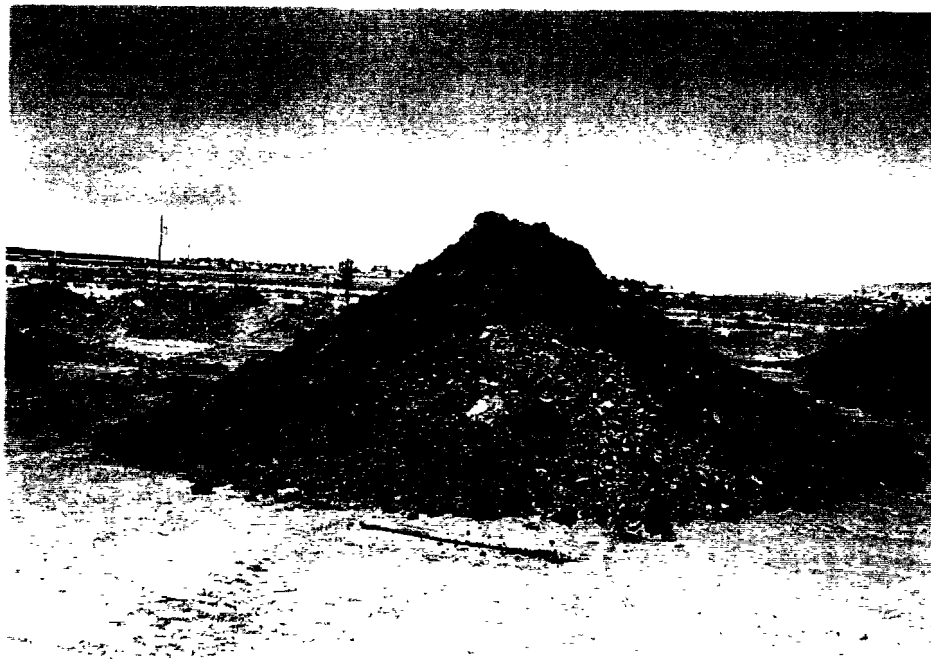
Photo 3-2 Temporary Stockpile of Hydrocarbon Soils Removed During Landfarm Construction

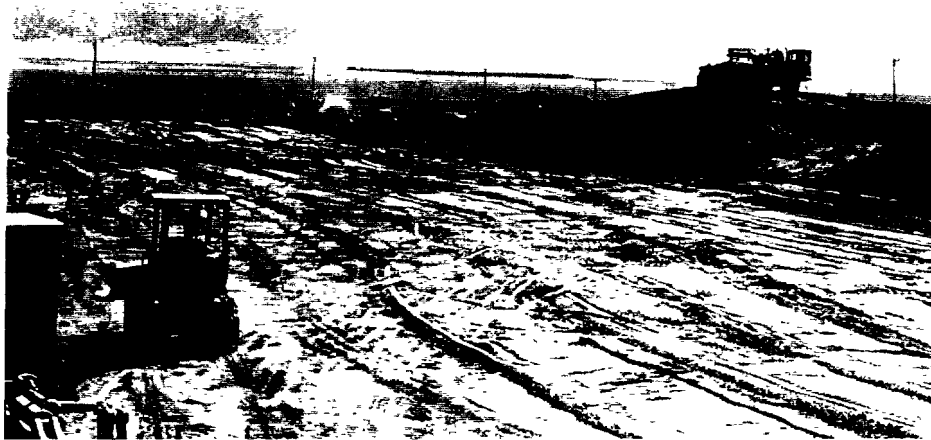
Concrete, old refinery piping, and oil stained soils were also encountered when preparing the surface immediately east of the landfarm for the temporary soil stockpile (Photo 3-4). Since the RA sequence was to construct the landfarm first and then to remove hydrocarbon soil, the soils removed during subgrade preparation were stockpiled in an adjacent location and the oil-stained soil and piping was scheduled for removal during hydrocarbon soil excavation work.

Photo 3-3 Temporary Stockpiling of Soils Excavated During Landfarm Subgrade Construction

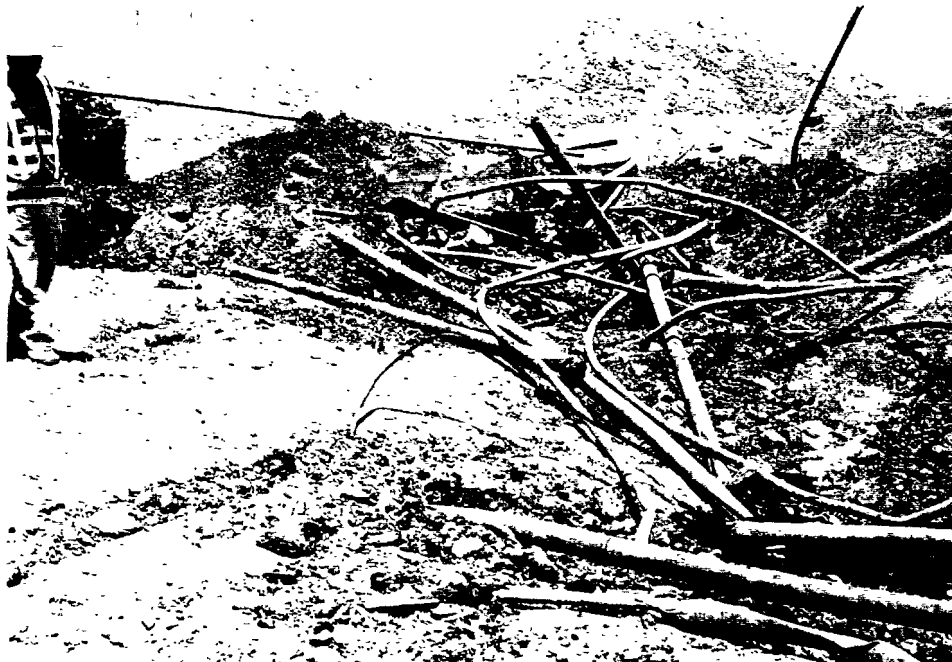
Photo 3-4 Hydrocarbon Soils and Piping Encountered East of the Landfarm

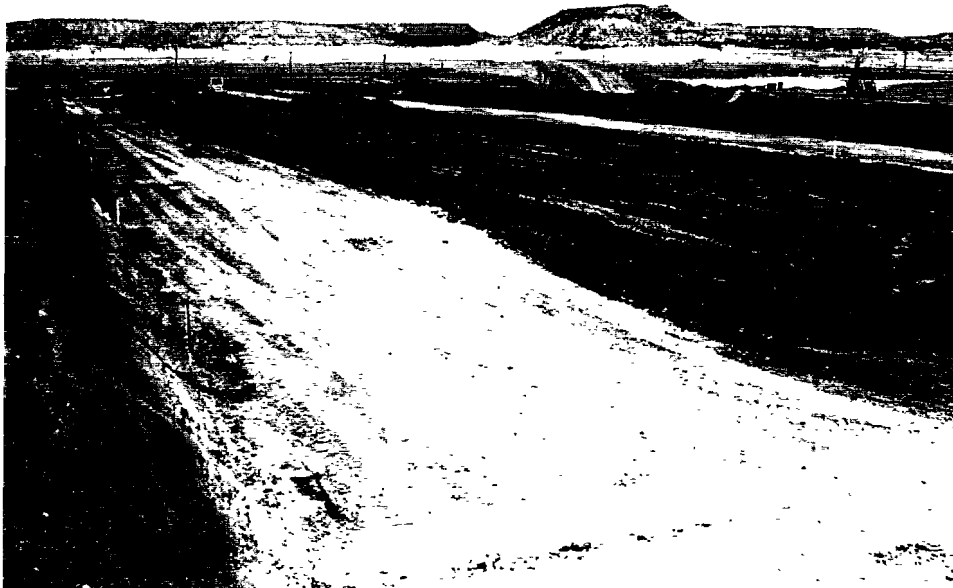
The liner was constructed in accordance with the RD. The clay was brought in by truck and spread out in a 9-inch lift with dozers as shown in Photo 3-6. Water was applied and the clay soil disked during placement in the landfarm as shown in the photograph in Photo 3-7 in order to achieve optimum moisture for compaction. The clay liner was compacted using dozers and a sheep's foot roller. Water was applied continuously during compaction of the clay.

Photo 3-6 Dozing Clay Layer During Construction of the Liner

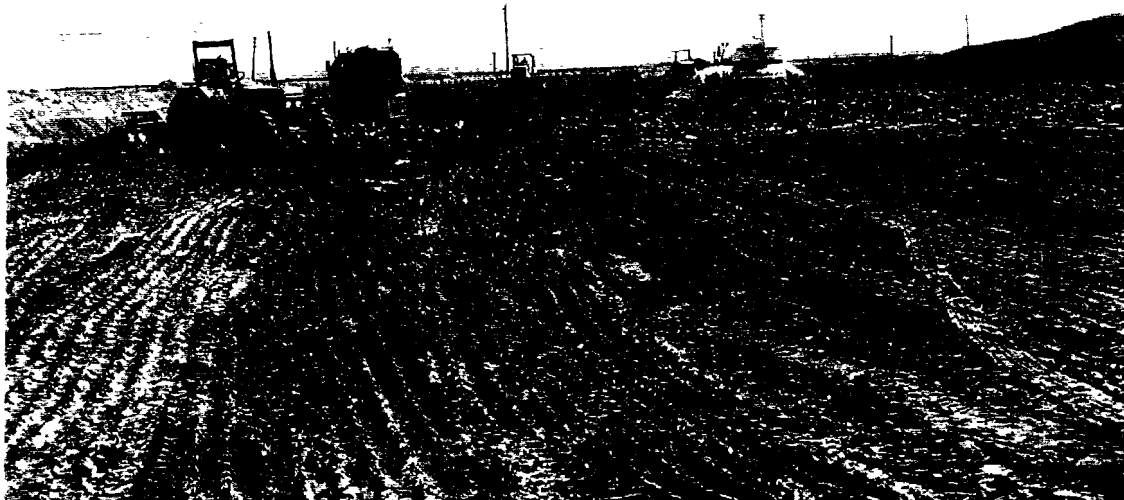
Photo 3-7. Applying Water and Disking Clay Soil to Obtain Optimum Moisture

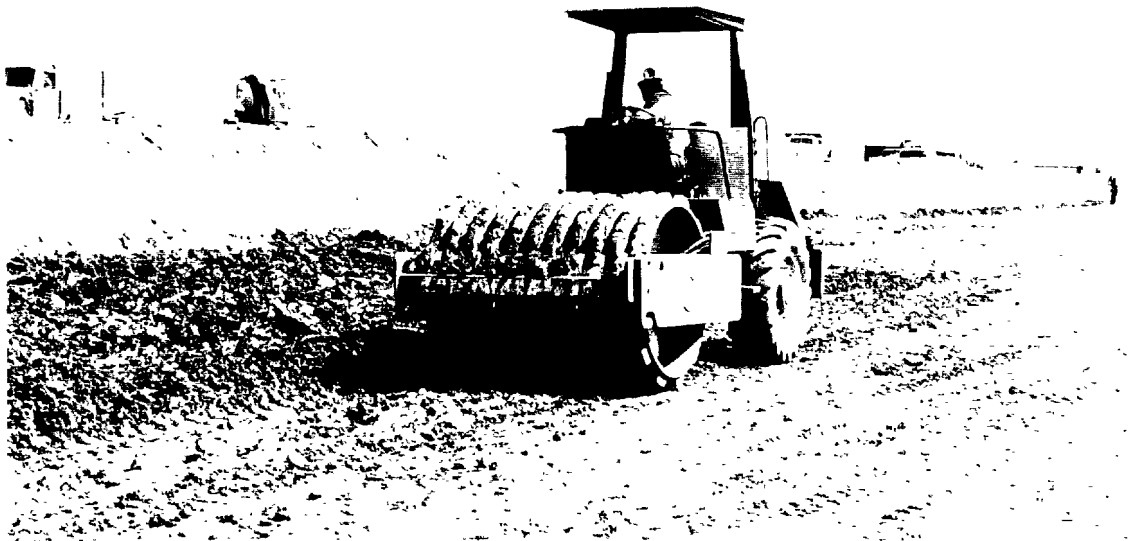
Moisture and compaction testing was conducted during liner construction to demonstrate compliance with RD construction specifications. In one area, where the moisture was outside the optimum range, the liner was ripped as shown in Photo 3-8. Additional moisture was applied using the water truck and the clay was recompactd using a sheeps foot roller as shown in Photo 3-9.

Photo 3-9 Re-Compaction of the Clay Liner

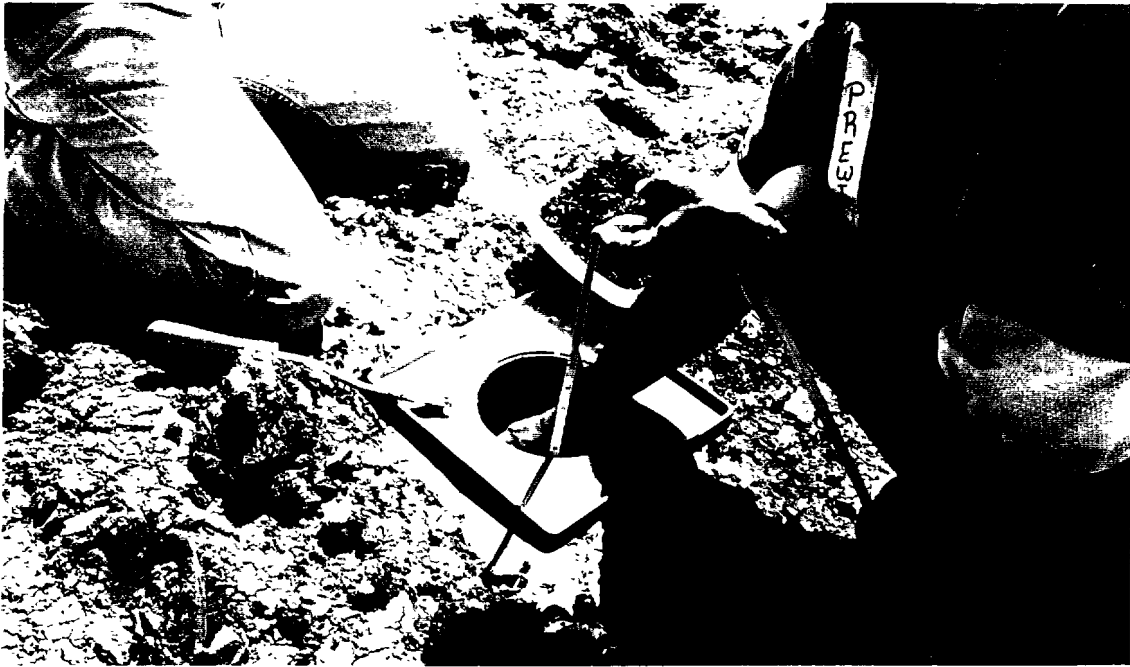
The sand cone test involves excavating a hole in the compacted clay liner. To provide additional verification of liner thickness, the thickness at each test location was measured as shown in Photo 3-11. The “in situ” dry density of the liner material was determined from the sand cone test procedure (ASTM D 1556) applied in the field as shown in Photo 3-12.

Photo 3-11. Measurement of Clay Liner Thickness at Sand Cone Test Hole

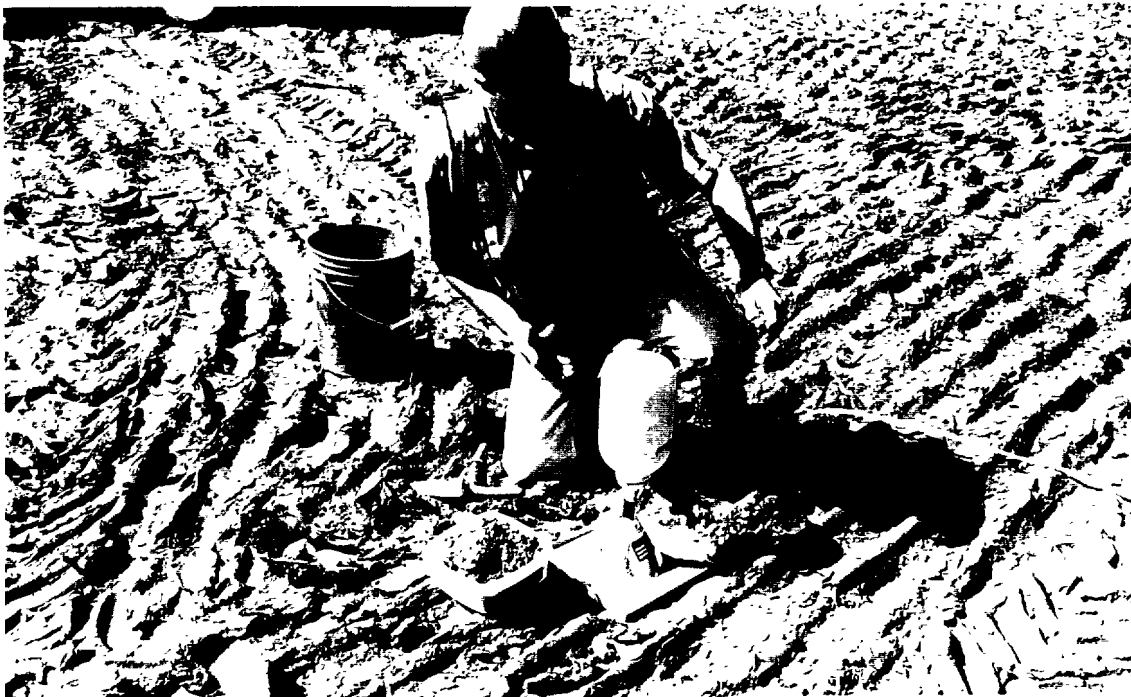
The results of the sand cone tests are provided in Appendix 3.3 and are summarized in Table 3-1. The “in-situ” dry density determined from the sand cone test was divided by the maximum dry density from the standard Proctor test of the upper three-feet of borrow area soils to determine the percent compaction. The results of the nuclear density gage measurements taken at 9 different locations are also provided in Appendix 3.3 and are summarized in Table 3-2. The results of both testing procedures demonstrated that the liner was compacted in accordance with the RD to a minimum of 95 percent of MDD.

Photo 3-12. Sand Cone Compaction Test of Clay Liner

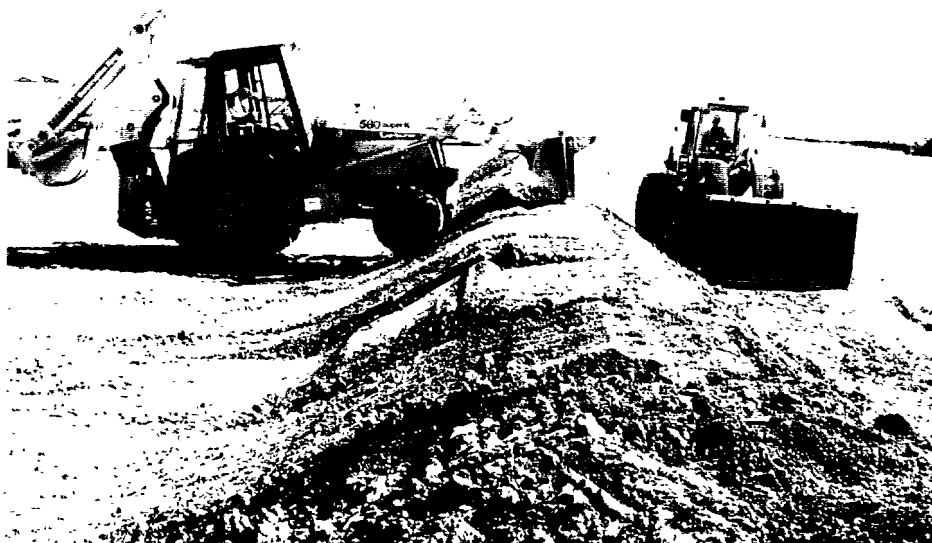
Photo 3-13. Construction of Run-on/Run-off Protection Berm

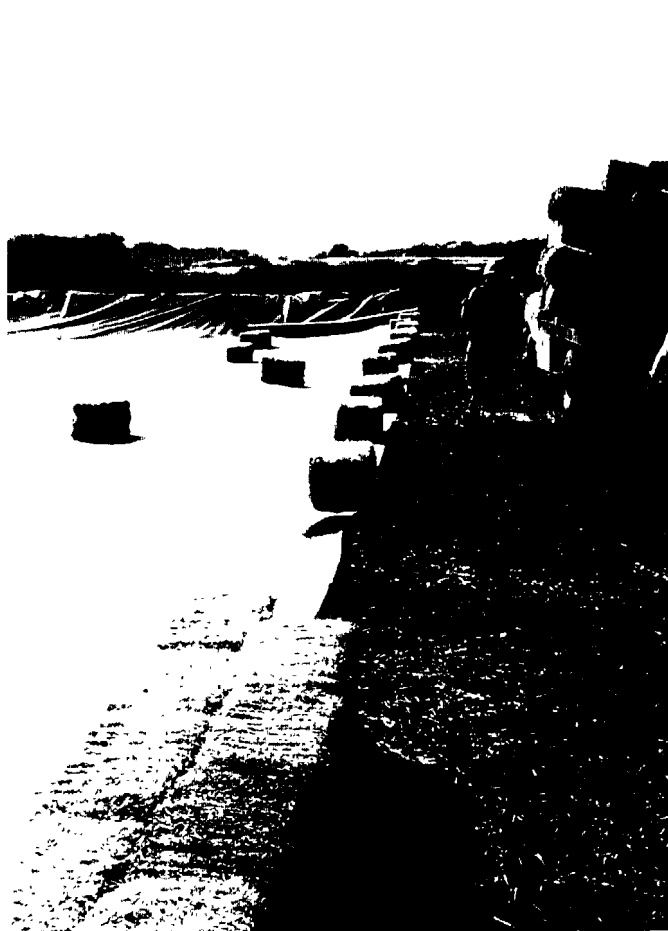
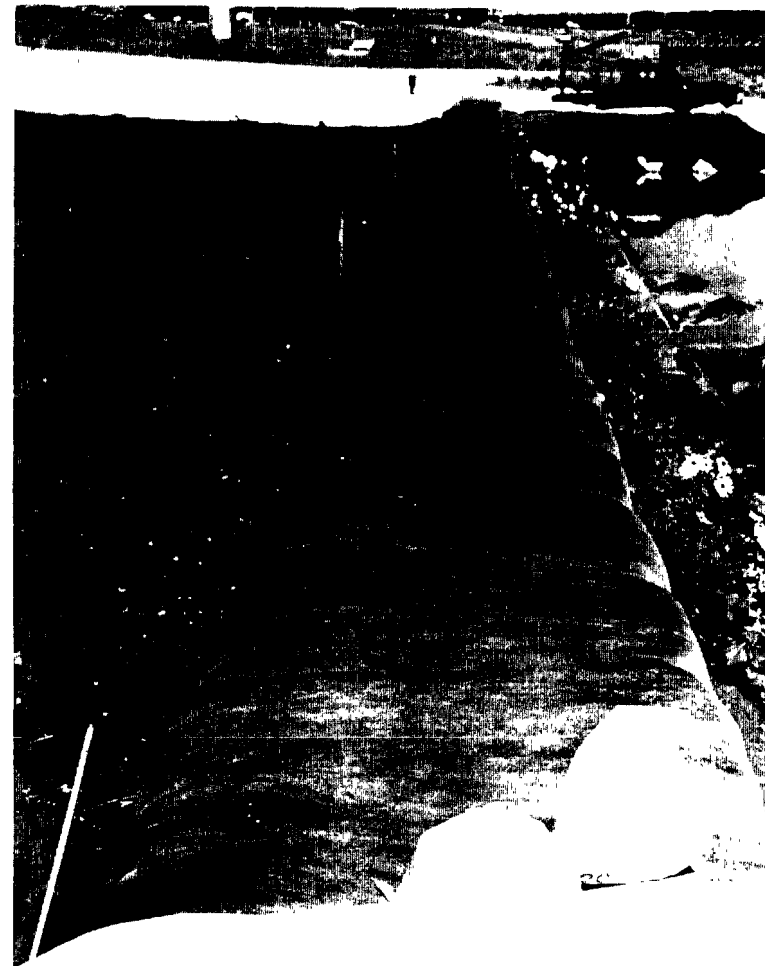
The hay bale berm was installed across the toe of the landfarm at the entrance to the collection basin as shown in Photo 3-15. The purpose of the hay bale berm is to prevent transport of landfarm soils into the collection basin during storm run off and to allow run off and seepage of any saturated flow above the clay liner to freely drain into the collection basin. The hay bale berm was covered with a nonwoven needlepunched geotextile, 180 EX from American Excelsior (See material cut-sheet provided in Appendix 3.4). This geotextile was approved by ARCO/EPNG and EPA oversight for covering the hay berm. The collection basin construction was completed on June 19, 1996.

Photo 3-15. Hay Berm Installation at Toe of Landfarm Treatment Cell

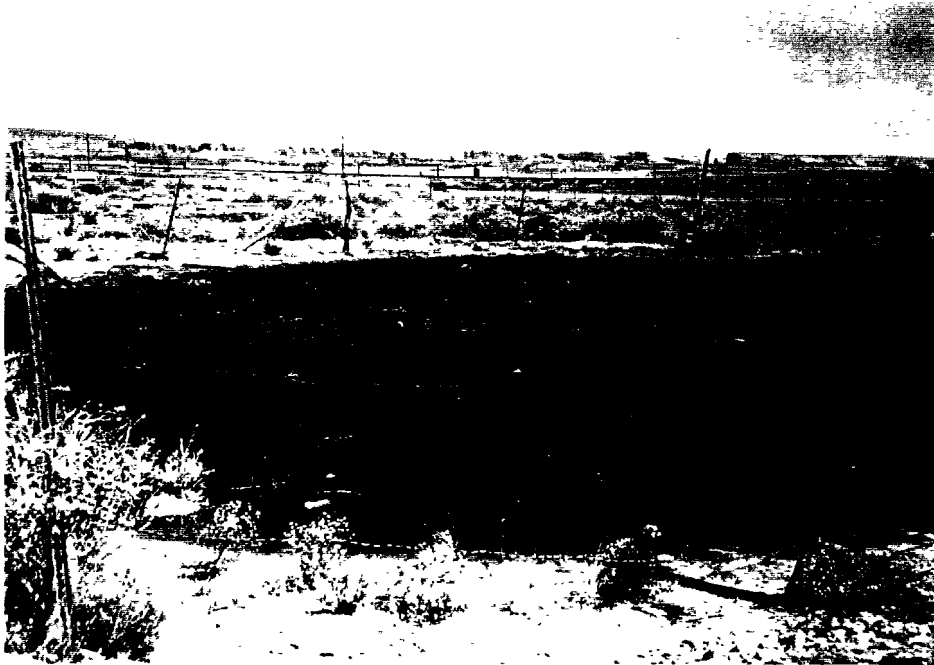
During the RI, the locations and volumes of hydrocarbon contaminated soils were determined from historical and recent aerial photographs, site inspections, and soil chemical data from sampling. The hydrocarbon soils in the Separator Area and Office Area were excavated during previous RA activities conducted during 1995 as described in Chapter 2. The remaining hydrocarbon-contaminated soils identified in the RI and RD were field located in March and April of 1996 prior to the start of excavation. The West Pits were readily identified in the field and the perimeter of each pit was evident from the pit berms as shown for the Fence Pit in Photo 4-1.

Photo 4-1. The Fence Pit Prior to Excavation

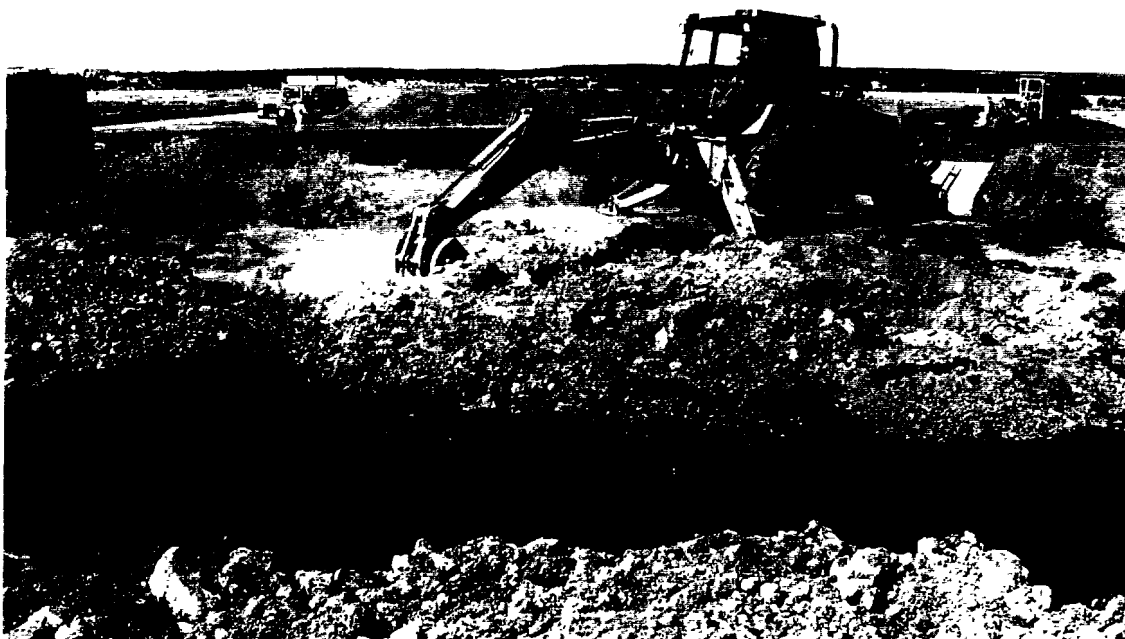
Hydrocarbon-contaminated soils in all the West Pits locations were initially excavated to the target depth of two feet. The Fence Pit, the A Pit, and one location in the S Pit were excavated to a depth of four feet because hydrocarbon sludge was found at depths below two feet. Drill cuttings and dry hydrocarbon soil from the landfarm construction were blended with wastes in the Fence Pit, prior to and during excavation, to adsorb water and oil which helped facilitate excavation with a track hoe as shown in Photo 4-2. This also helped in the subsequent stage of soil homogenization.

Photo 4-2. Excavation of The Fence Pit

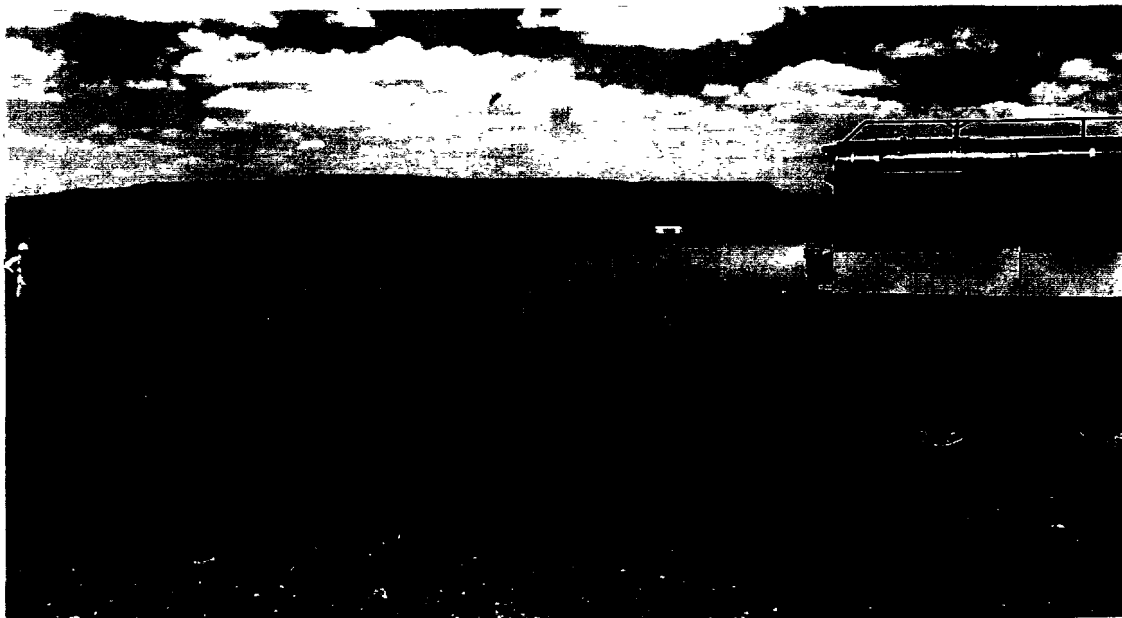
Photo 4-3. Water Spraying for Dust Control During Excavation of West Pits

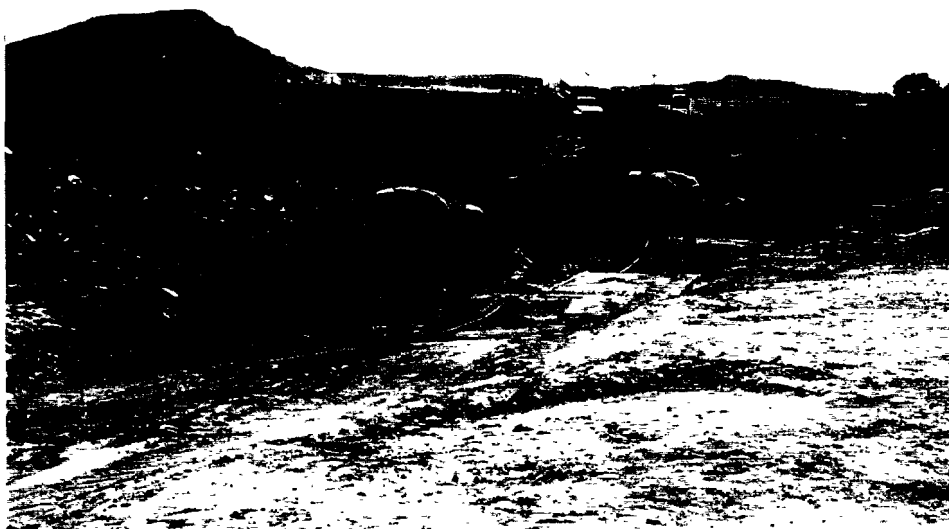
Excavations in the Railroad Area and associated confirmatory sampling locations are also shown in Figure 4-1. Composite samples RR-CS1 through RR-CS6 were taken following excavation of more than two feet of soil from these hydrocarbon soil excavations as shown in Photo 4-4. The calculated total benzo(a)pyrene equivalent from confirmatory sampling in the excavations of greater than two feet in depth in the Railroad Area ranged from 0.43 (all concentrations less than detection) to 9.83 ppm. These results confirm that the excavation of hydrocarbon soil in the Railroad Area met the 20.3 ppm total benzo(a)pyrene equivalent clean-up criteria.

Photo 4-4. Confirmatory Sampling of Hydrocarbon Soil Excavation in Railroad Area

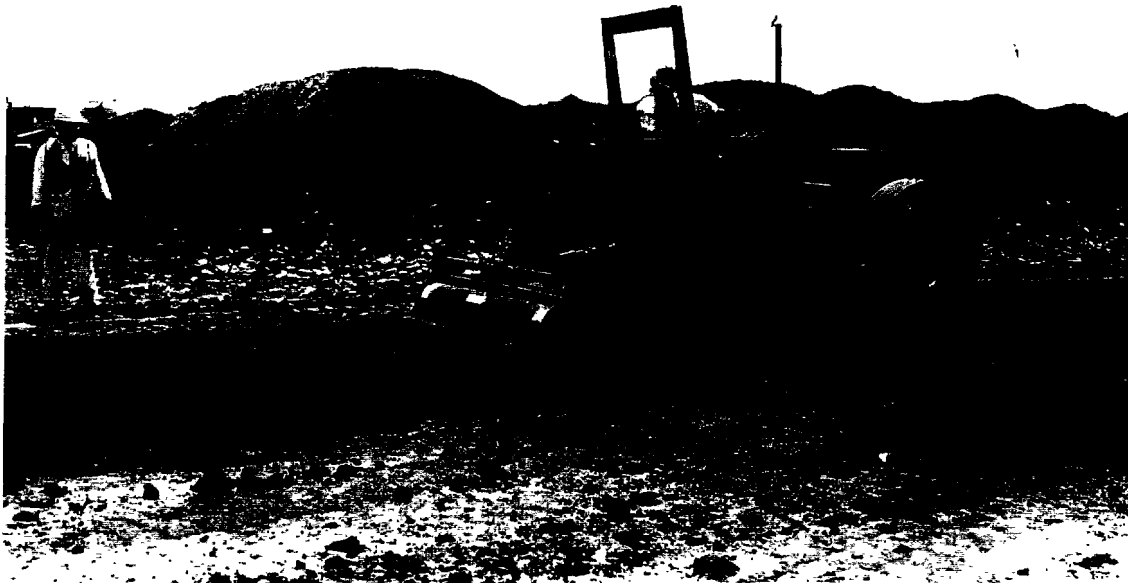
Soil homogenization was conducted in batches at a soil preparation area. The excavated hydrocarbon soils and the West Pits contents were dozed into a preparation bed to a depth of about 6 to 8 inches. The soils and wastes were homogenized using disc and rotor-tillers as shown in Photo 5-1. Rocks, pipe and construction debris were removed by hand or by dozing during soil homogenization. The soil preparation locations are shown on Figure 5-1. The soil preparation areas were located adjacent to the homogenized soil stockpiles. The soil preparation areas and homogenized soil stockpiles were located near but outside of the West Pits excavations. The dimensions of the homogenized soil stockpiles and preparation areas were restricted to as small an area as was practicable in order to reduce the volume of later surface soil removal required beneath the soil preparation and soil stockpiling locations.

Photo 5-1. Soil Homogenization Using Disc with Homogenized Soil Stockpiles in Background

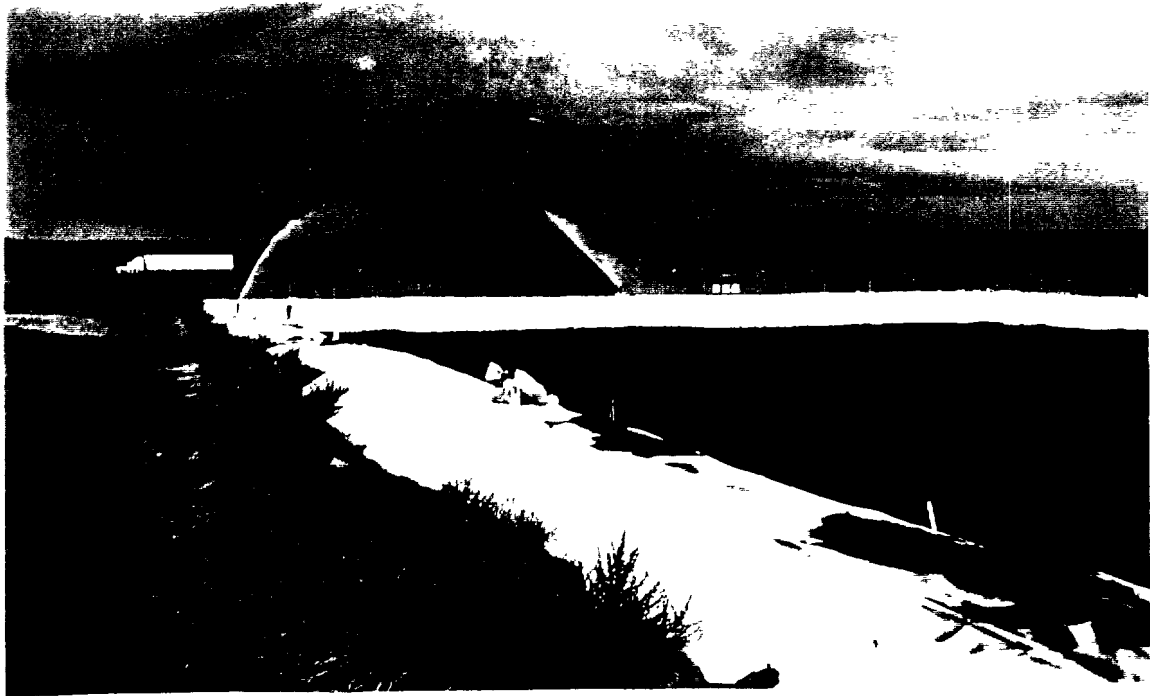
During August 1996, eight five-point composite soil moisture samples were taken on a weekly basis. The results, included in Appendix 7.3, show average weekly moisture contents at 8%, 10.7%, 12.5% and 21.7%. The average moisture content for the first three weeks were slightly

Photo 7-7. Landfarm Irrigation Sprinkler System

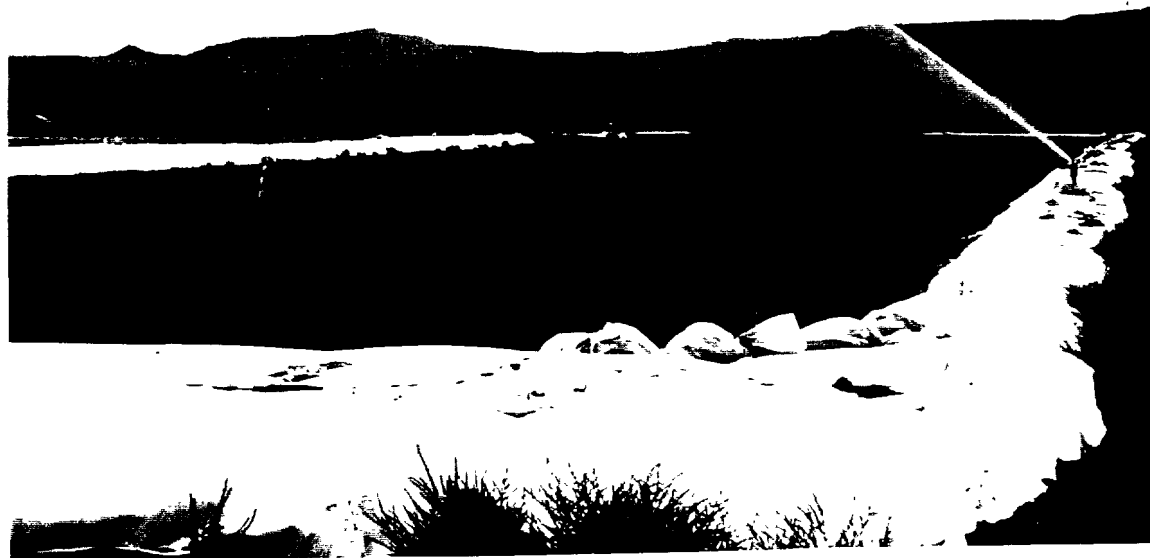
Photo 7-8. Landfarm Irrigation Sprinkler System

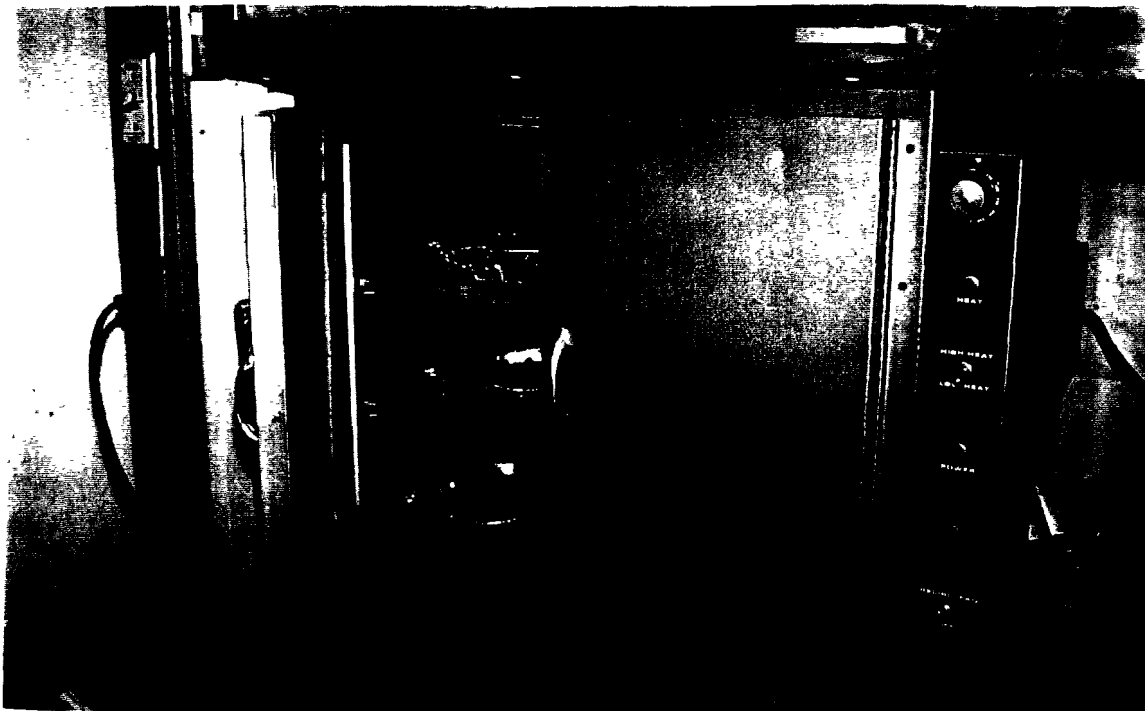
Photo 7-10. Landfarm Moisture Sample Drying

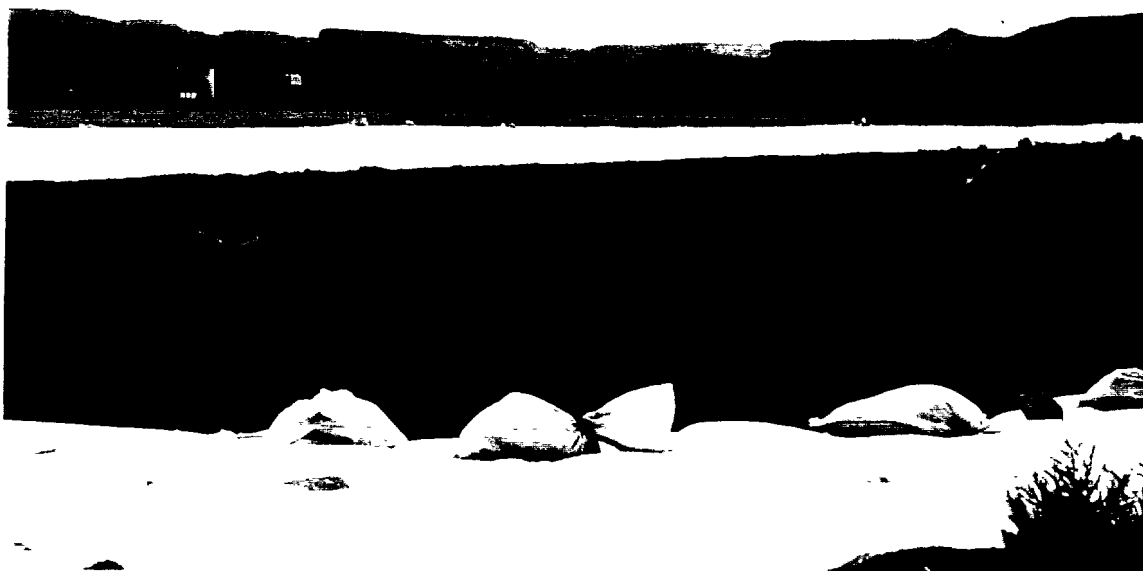
Weekly moisture sampling of the landfarm soils continued during the month of September and October 1996. The sampling results, summarized in Appendix 7.3, show moisture content for September ranged from 19.4% to 41.8%, with an overall average for the month at approximately 26%, which is slightly above the optimum range of 13% to 20%. The October moisture content ranged from 18.9% to 22.4%, with an average of 20.4%.

Photo 7-11. Landfarm Portable Sprinklers

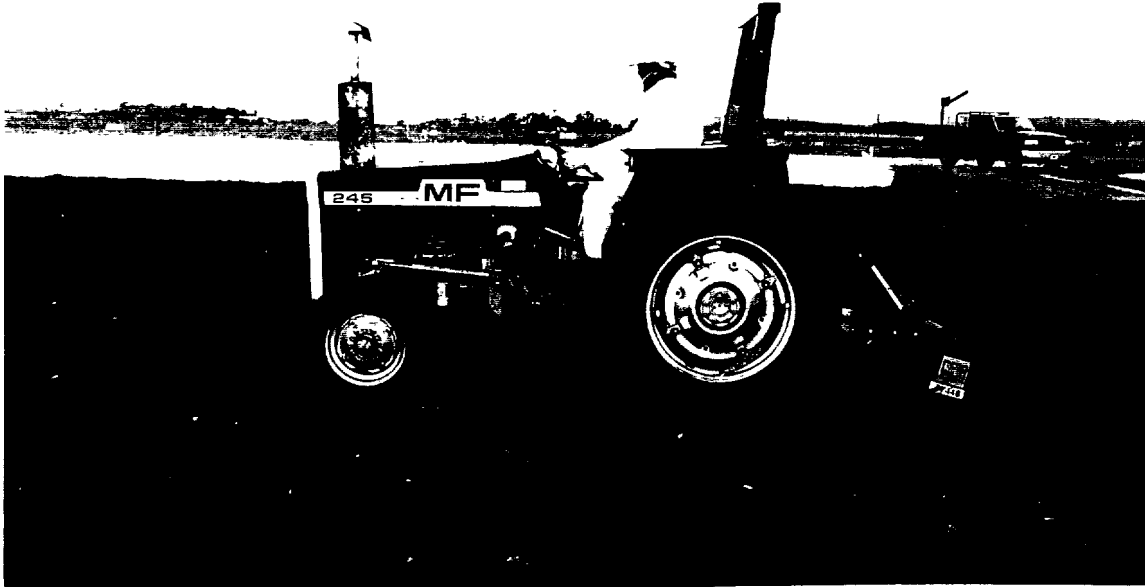
The O&M tilling activities are recorded in the Landfarm Operation and Maintenance log, provided in Appendix 7.2. Since the landfarm treatment standards have been attained, as confirmed by the performance sampling discussed in Section 7.7, the O&M landfarm soil tilling activities were terminated in October 1996.

Photo 7-12. Landfarm Soil Rotor Tilling

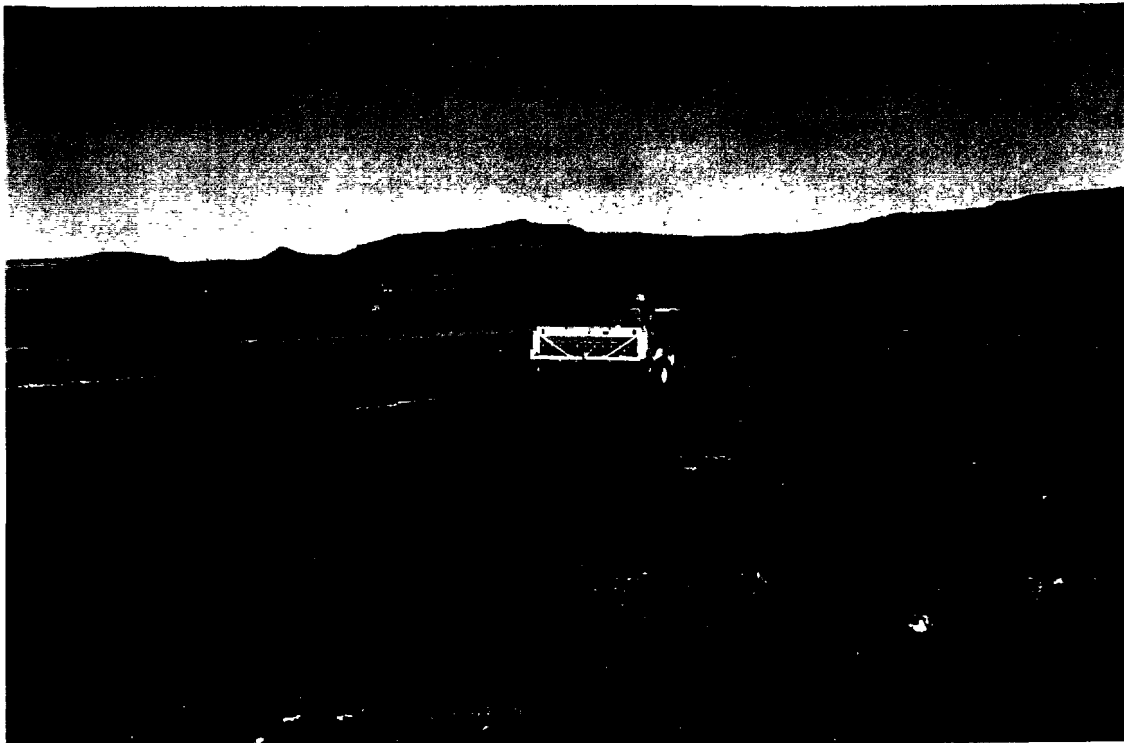
Photo 8-6. Seeding Fertilized and Disked Area Using a Seed Driller

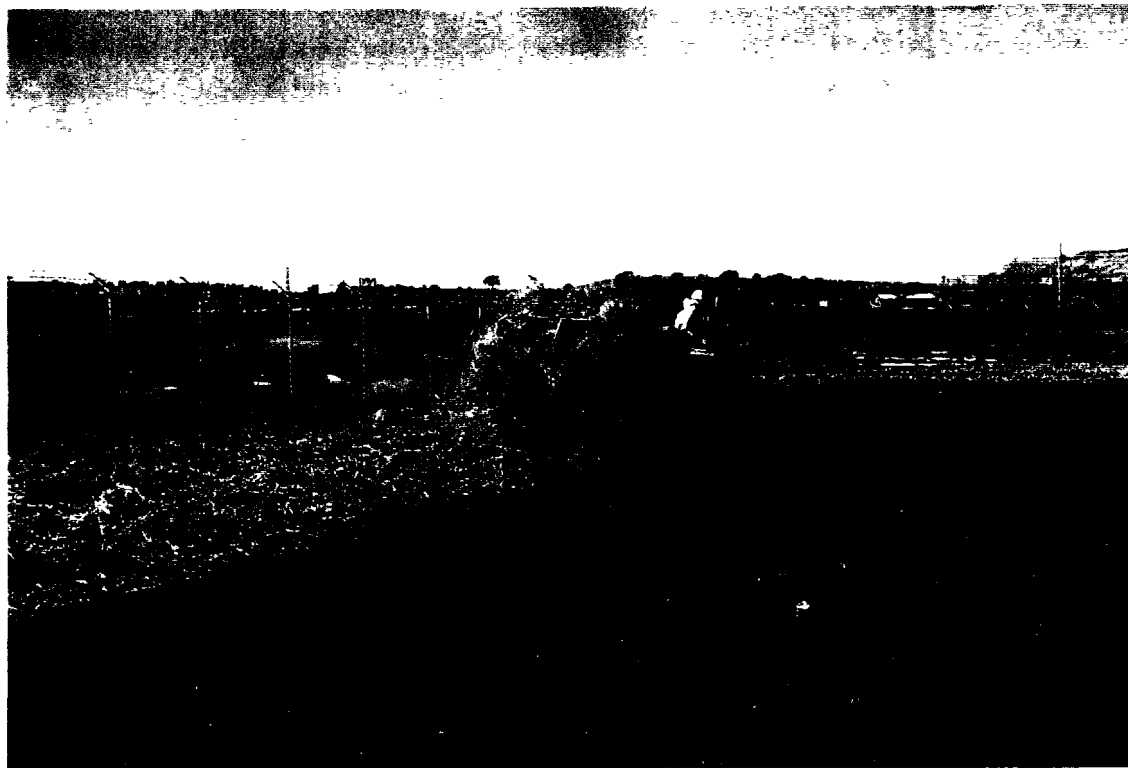
Photo 8-7. Straw Mulching of Seeded Area

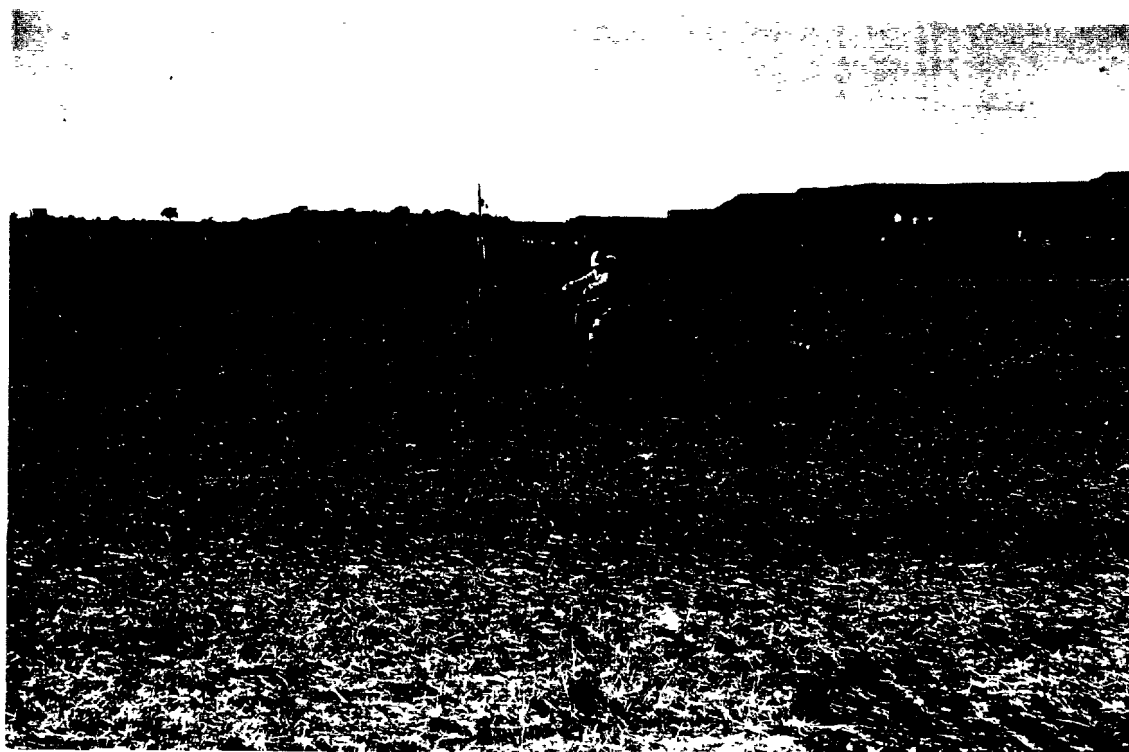
Photo 8-8. Crimping of Straw Mulch

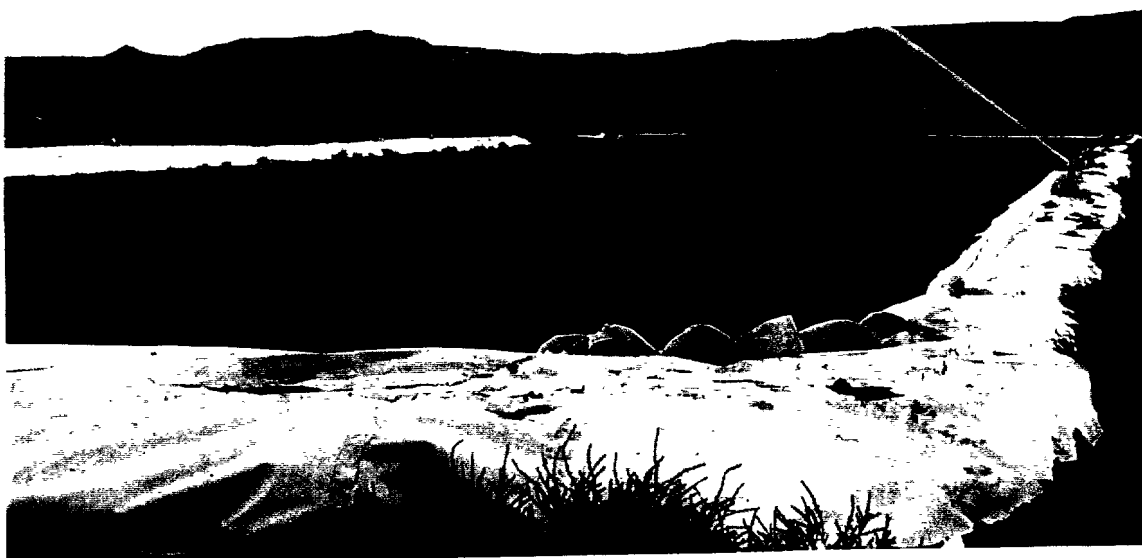
Photo 8-9. Landfarm During Operation, August 1996
